NASA/TM-2001-210846

Structural Testing of a Stitched / Resin Film Infused Graphite-Epoxy Wing Box

*Dawn C. Jegley and Harold G. Bush
Langley Research Center, Hampton, Virginia*

April 2001

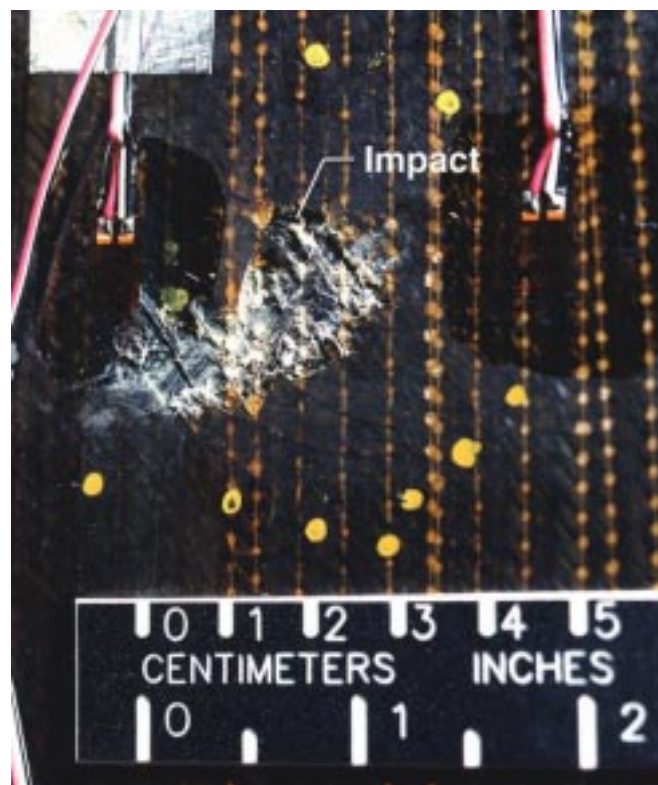
Impact damage was induced by the use of a dropped-weight and an air-powered projection mechanism. Impact damage was inflicted to the upper and lower surfaces of the wing. A dropped-weight impactor was used to inflict three impacts with an energy level of 100 ft-lb to the upper cover panel. The locations of these damage sites are shown in figure 2. A weight of 25 lb with a 1-inch diameter tup was dropped vertically from 4 feet, resulting in the damage shown in figure 16. Impact damage between ribs 4 and 5 is shown in figure 16a, impact damage at rib 9 is shown in figure 16b, and impact damage at rib 13 shown in figure 16c. The dots surrounding the impact site in each figure are the limits of the damage, as determined by ultrasonic scans taken immediately after damage was inflicted and before wing loading. The damage was barely visible to the eye and the extent of the damage as determined by using NDE ranged from 1.4 inches to 2.5 inches in diameter around the impact site. The depth of the damage was also measured and ranged from .01 to .05 inches. A description of the upper cover damage is given in table 5.

a) Site at rib 4
Figure 16. Upper cover impact damage locations.

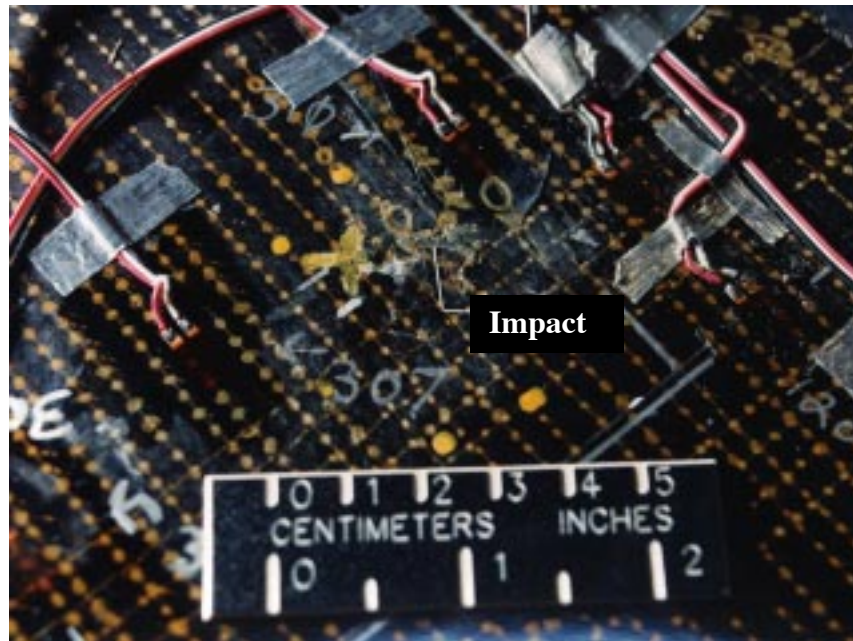
b) Site at rib 9
Figure 16. Continued.

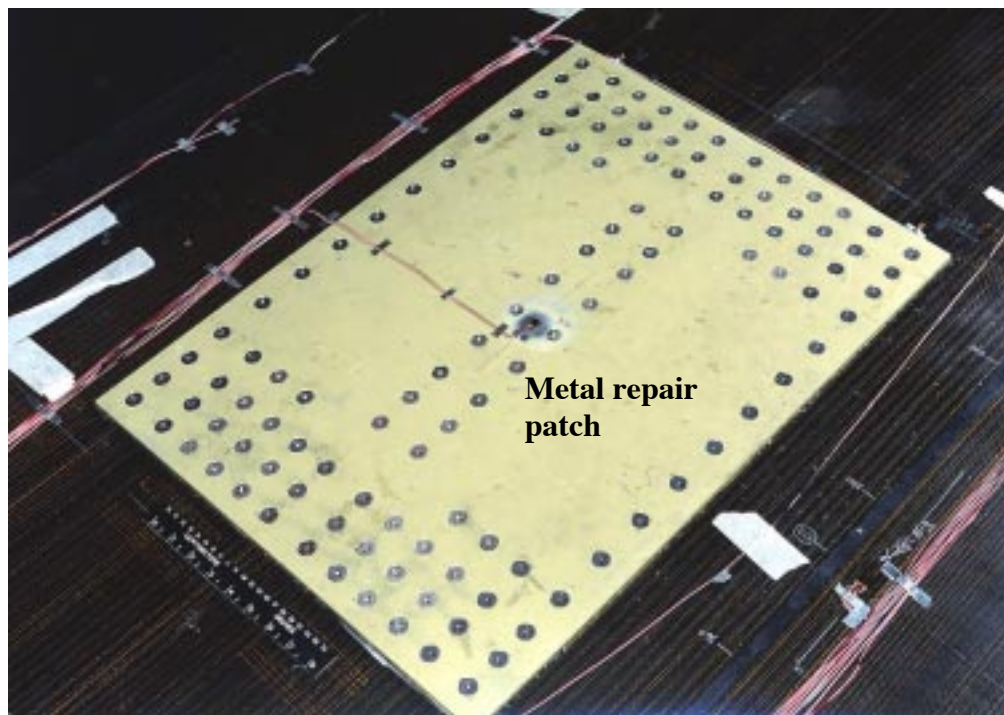
a) Upper cover panel
Figure 18. Repairs to cover panels.

Metal patch repairs were used to restore the wing to full load-carrying capability after test 7 in which the test article was subjected to load in the presence of discrete source damage. The region of damage was removed then the repairs added. The repairs consisted of a metal plate which conformed to the wing surface on the outer surface of the cover panels and internally spliced stringers. All parts of the repair were attached to the wing with mechanical fasteners. Sketches of the repairs are shown in figure 14. Photographs of the repairs are shown in figure 18.

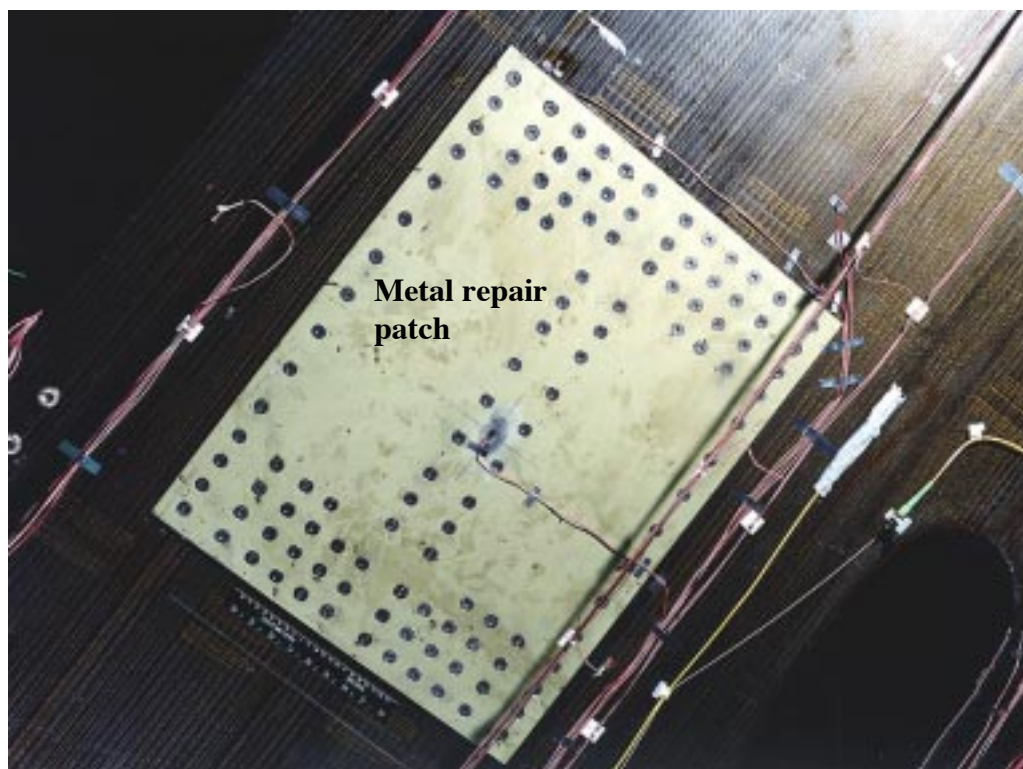
b) Lower cover panel.
Figure 18. Concluded.

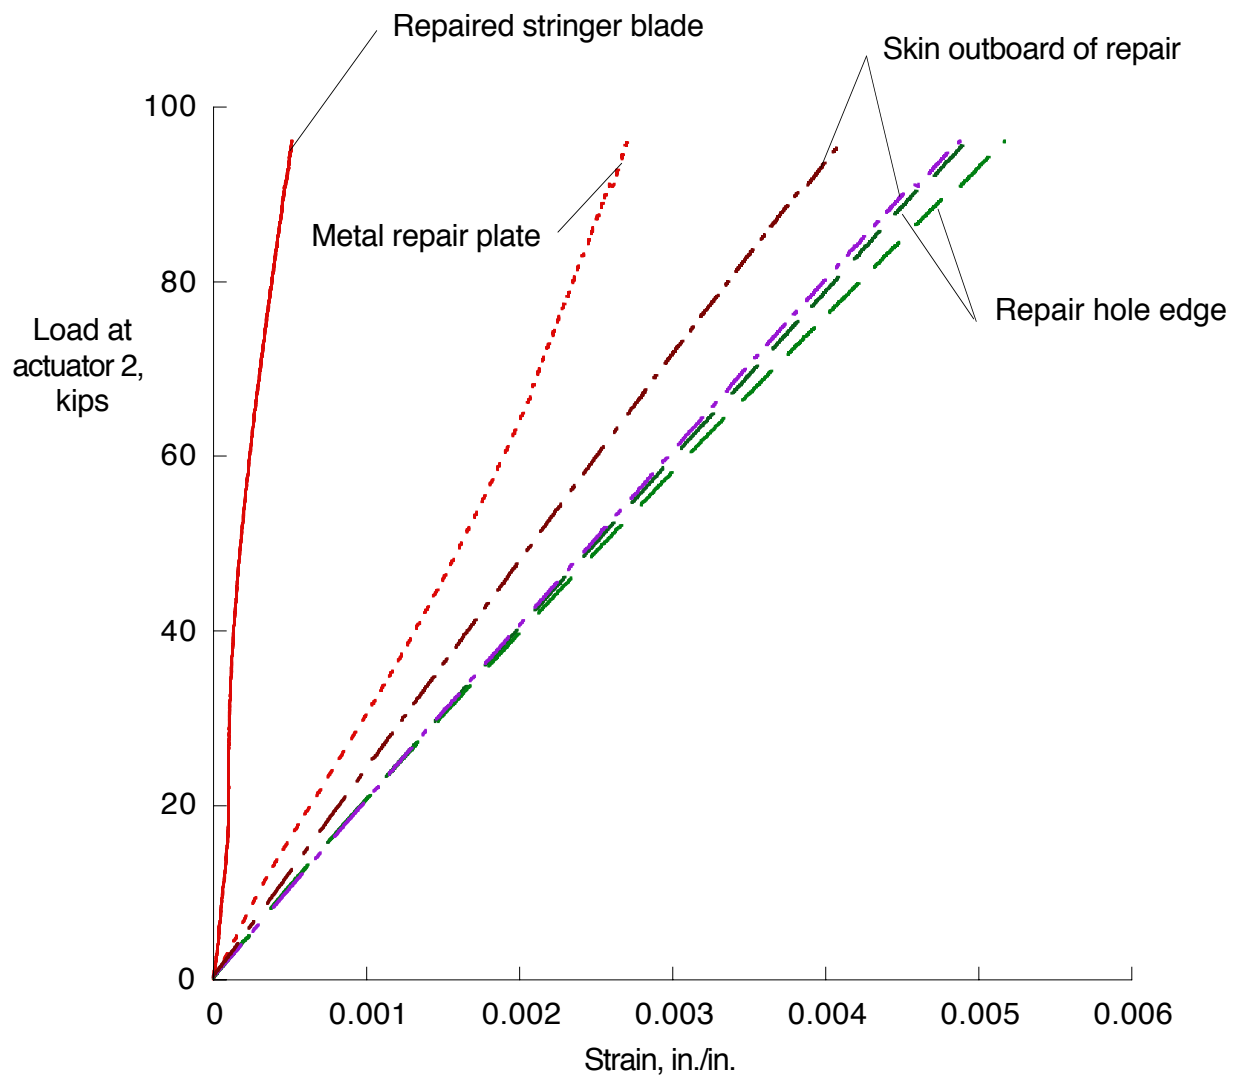
Both sawcuts were repaired prior to the final test (test 8). The strains measured in the lower cover panel repair are shown in figure 64. The solid line represents strain in the metal component of the spliced blade. The short dashed line represents the strain in the metal repair plate. The long dashed lines represent the strain at the edges of the repair bole. The alternating long and short dashes represent the strain in the composite skin immediately outboard of the metal plate. The location of these strain gages is shown in figure 14. Strains on the composite structure in the vicinity of the repair are linear and do not exceed 0.005 in./in. Strains in the metal repair components display nonlinearity but remain less than 0.003 in./in.

Figure 64. Strains in lower cover repaired region. Strain gage locations are shown in figure 14.

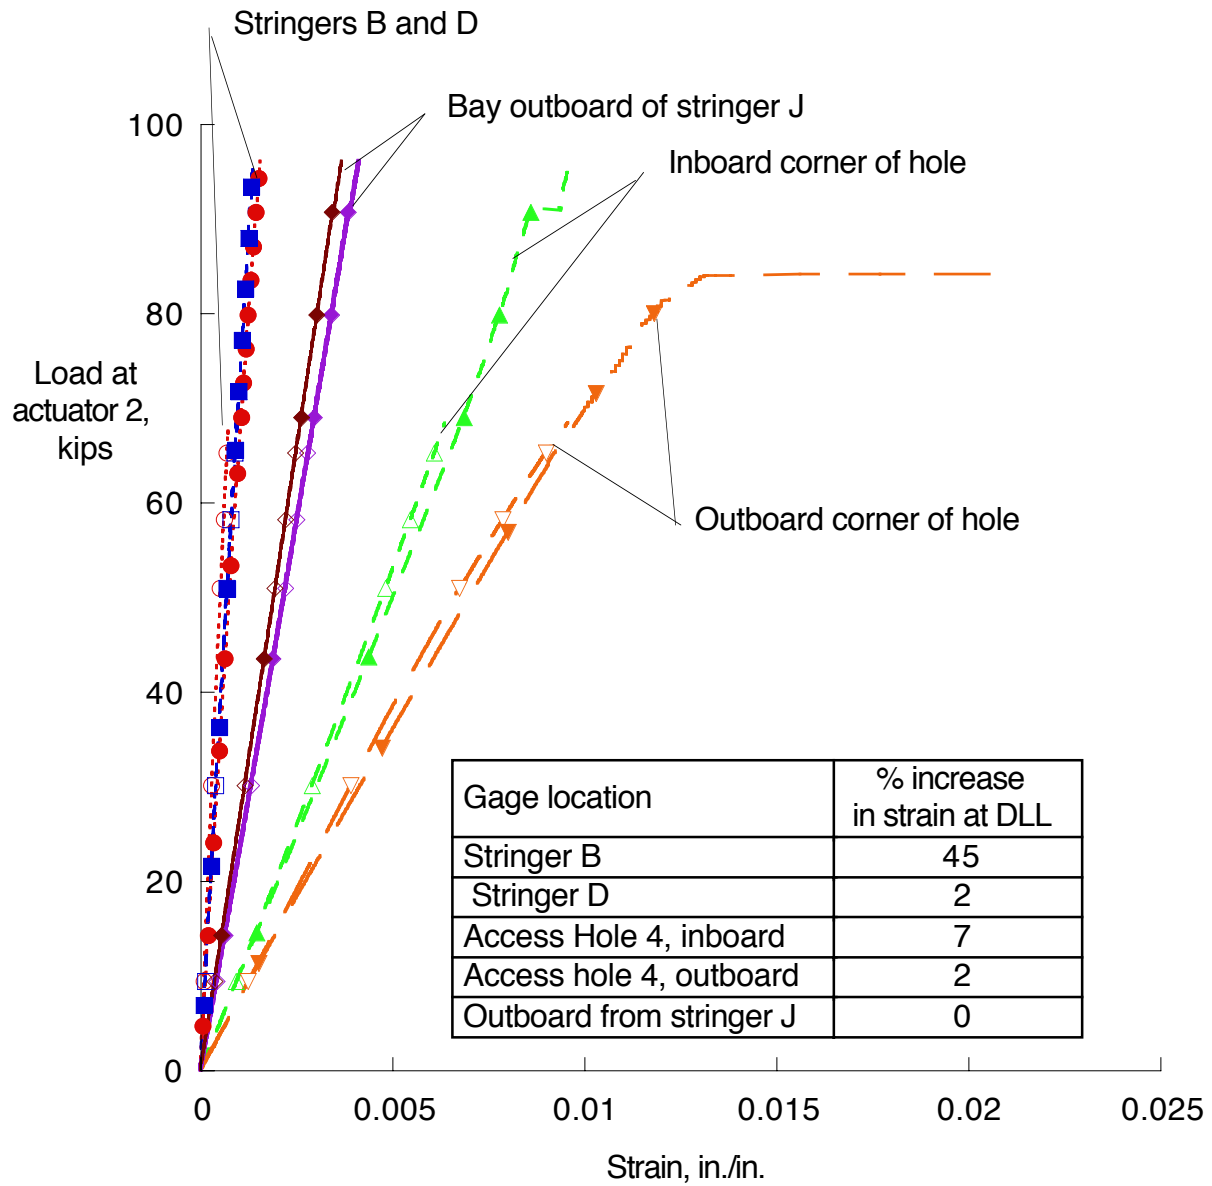
The effect of the lower cover panel repair on the behavior of the lower cover panel strains can be seen by comparing the strains measured in test 6, when the wing was loaded to DLL, to the strains measured in the final test. Measured strains at six locations between ribs 8 and 9 in the lower cover panel are shown in figure 65. These locations are shown in figure 8 as L4 (skin outboard from stringer J), L5 (stringer D) and L6 (stringer B) and at the corners of access hole 4. Solid lines represent strain in the skin outboard of stringer J. Dashed lines with progressively shorter dashes represent strains moving toward the front spar. Open symbols represent data from test 6 and filled symbols represent data from test 8. The repair causes

an increase in strain in the blades of the stringers adjacent to the spliced stringer. At the load values corresponding to DLL, an increase of 45% in stringer B, 2% at the outboard corner of the access hole and 7% at the inboard corner of the access hole is seen. No increases in strain are seen in the skin near the rear spar in this bay. Significant local effects are seen but there is little effect away from the repair site. The effect of the repair on the strains at the access holes in the lower cover is presented in table 7 where strains measured at DLL in test 6 and in test 8 are shown.

Figure 65. Strains in lower cover panel between ribs 8 and 9 for tests 6 and 8. Stringer identification shown in figure 2b.

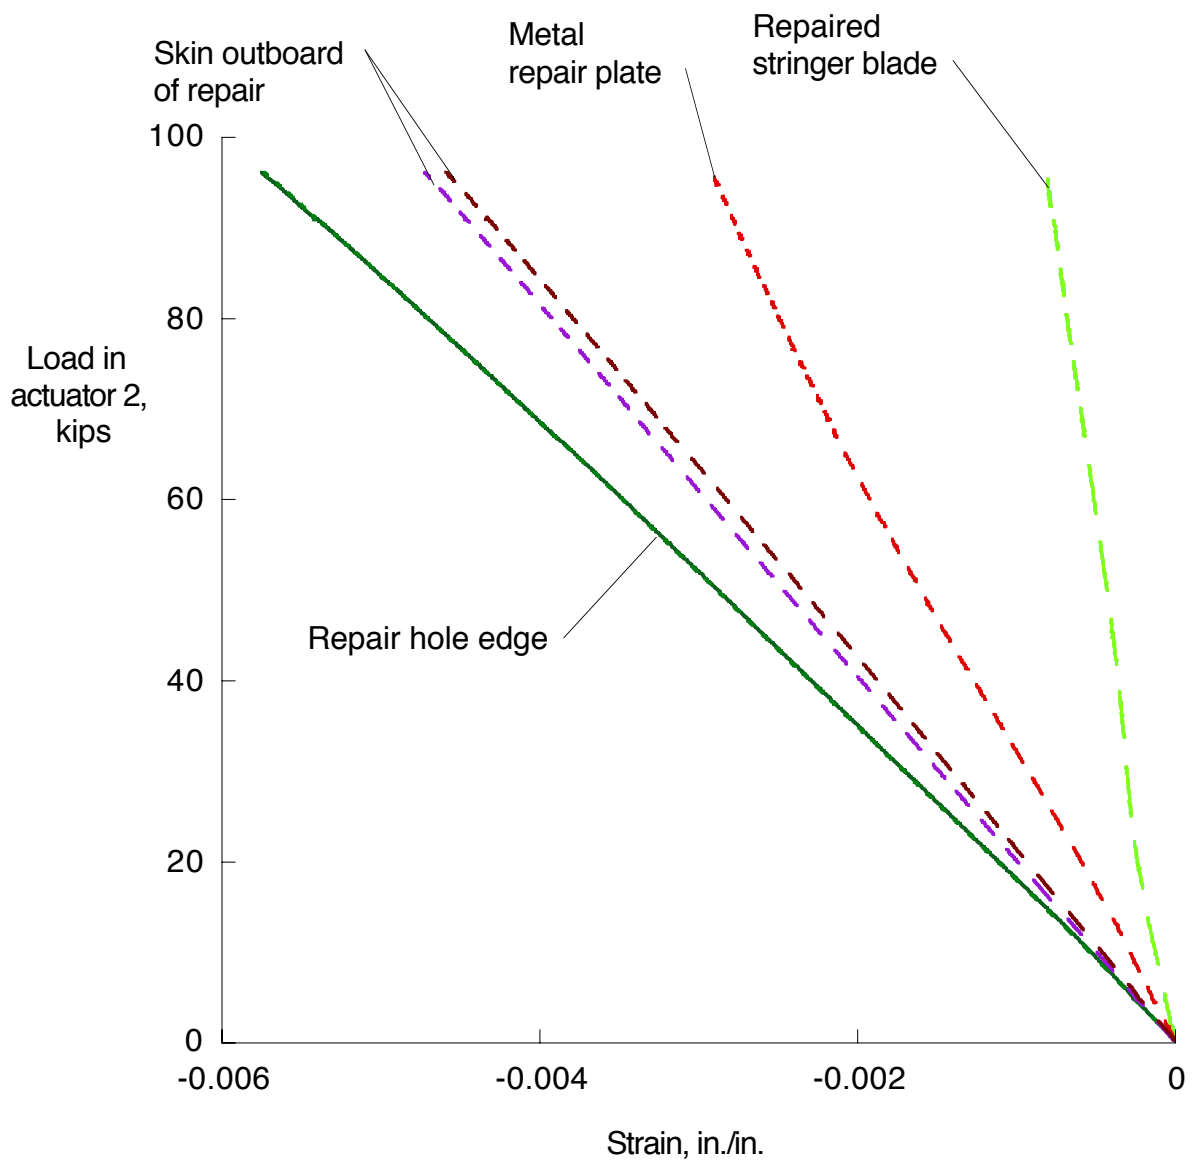
The strains measured in the upper cover panel repair are shown in figure 66. The solid line represents strain in the metal component of the spliced blade. The short dashed line represents the strain in the metal repair plate. The long dashed lines represent the strain at the edges of the repair hole. The alternating long and short dashes represent the strain in the composite skin immediately outboard of the metal plate. The location of these strain gages is shown in figure 14. Strains on the composite structure in the vicinity of the repair are linear and do not exceed 0.005 in./in. Strains in the metal repair components display nonlinearity but remain less than 0.003 in./in.

Figure 66. Strain in upper cover panel repair. Strain gage locations are shown in figure 14.

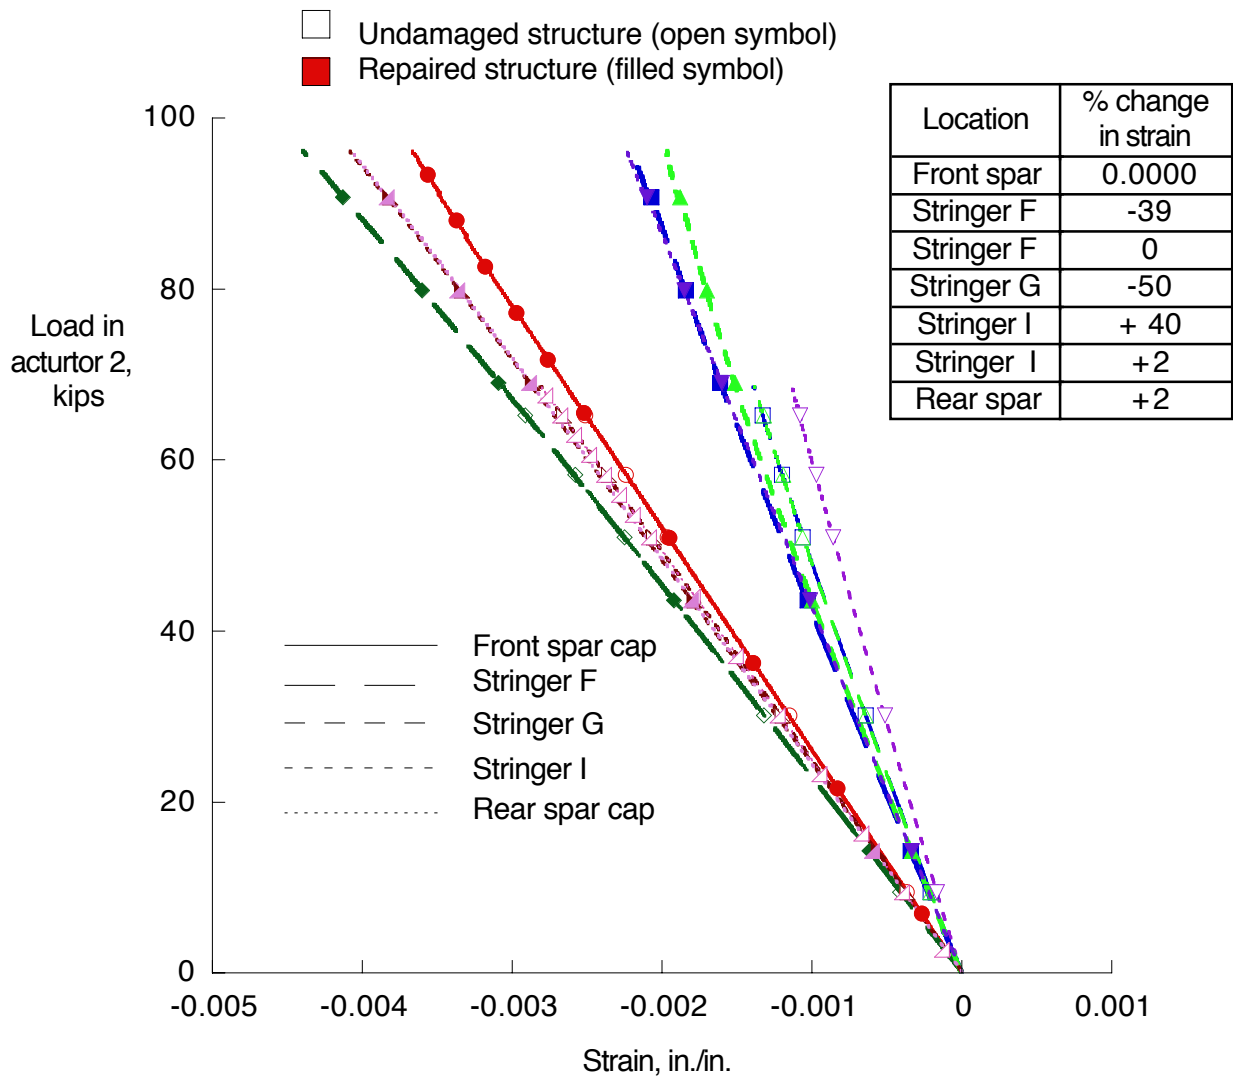
Measured strains at eight locations in the upper cover panel between ribs 10 and 11 are shown in figure 67. These locations are shown in figure 7 as U4 (rear spar cap), U5 (stringer I), U6 (stringer G), U7 (stringer F), and U8 (front spar cap). The solid lines represent the strain in the front spar cap. Long dashed lines represent strain in stringers G and I which are adjacent to the spliced stringer. Short dashed lines represent strain in stringer F. Open symbols represent data from test 6 and filled symbols represent data from test 8. The repair causes an increase in strain in the blades of the stringers to the rear of the spliced stringer and a decrease in strain in the blades of the stringers forward of the repair. At the load values corresponding to DLL, a decrease of 50% and an increase of 40% are seen in the adjacent stringers forward and aft stringers, respectively. The repair causes an increase in strain of 2% at the rear spar and has no effect on the front spar. The strain in the skin is effected little by the repair.

Figure 67. Effect of repair on measured strains in upper cover panel between ribs 10 and 11.

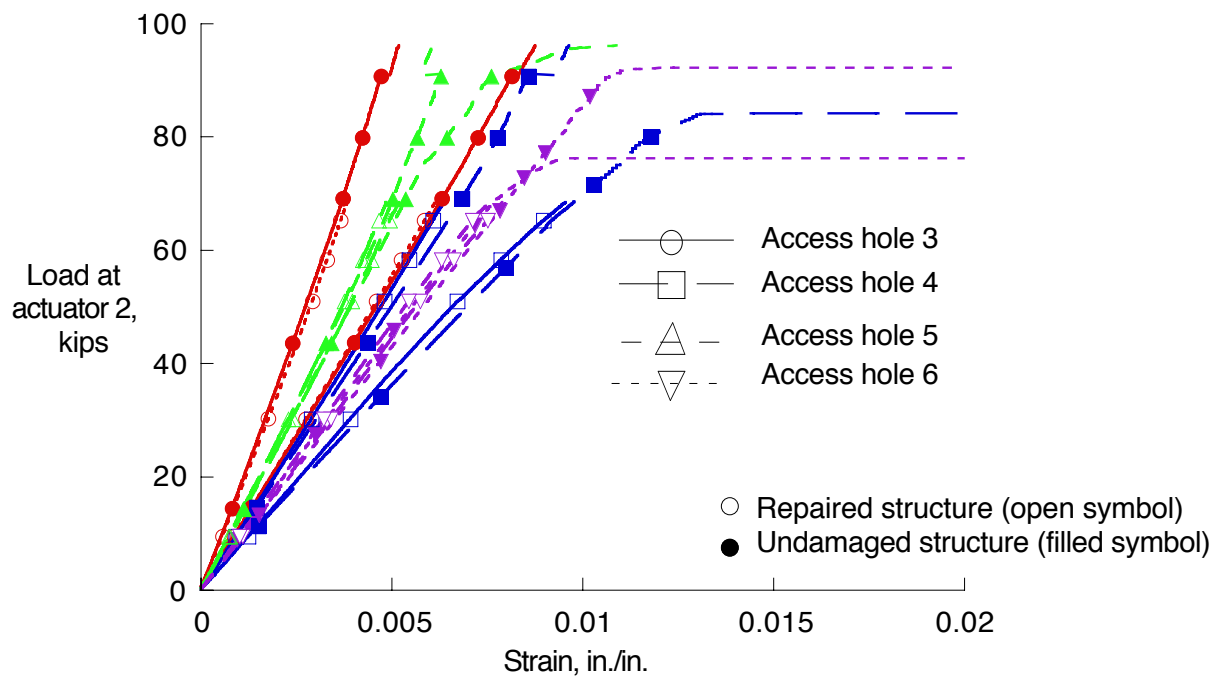
Table 8. Maximum Strain and Load at Actuator 2 at Access Hole Edges for Hole Failure Locations

Access hole	Location	Load kips	Strain in./in.
4	outboard	84	0.0132
5	outboard	96	0.0104
6	outboard	76	0.0096
6	inboard	92	0.0112

Figure 78. Measured strain at access hole edges for load to DLL and to failure in 2.5G load condition.

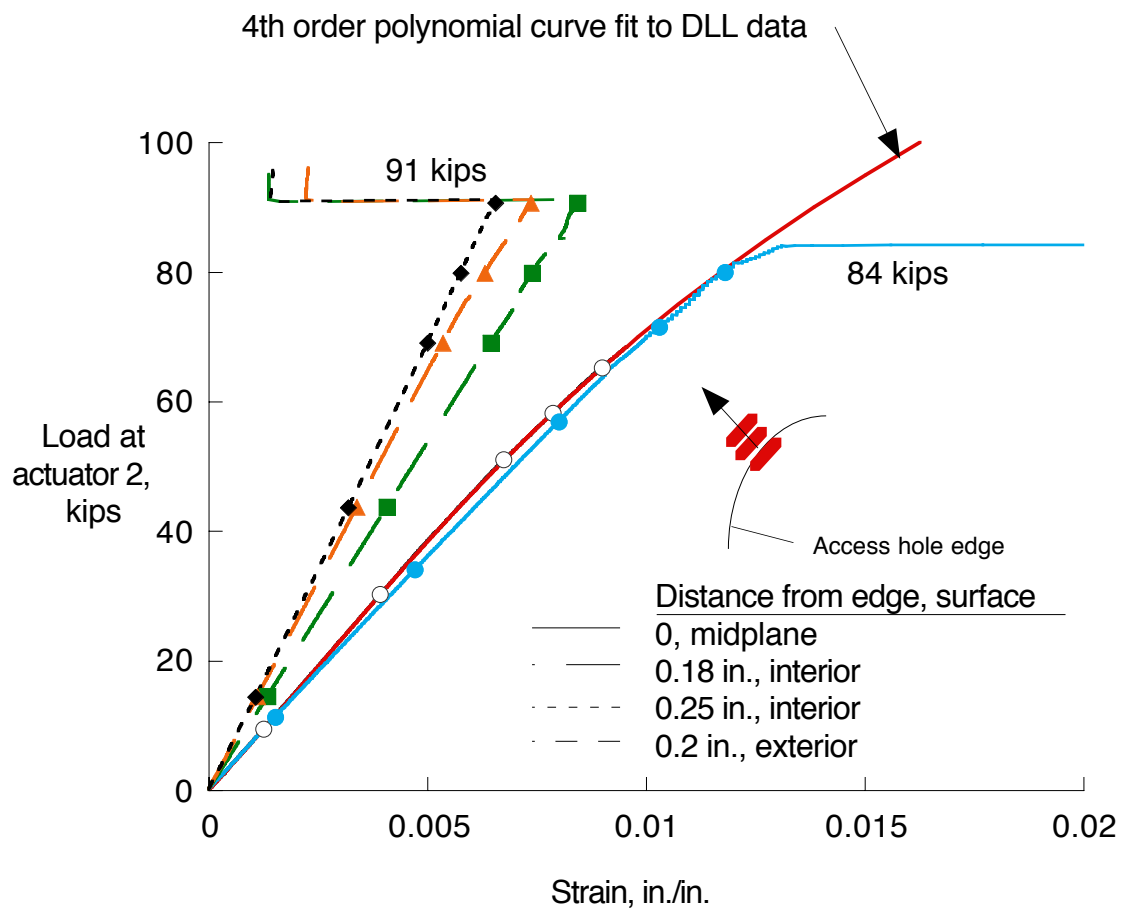
Figure 79. Strain at edge of access hole four.
